WATER HEATER MAINTENANCE PARTS & TOOLS

WATER HEATER MAINTENANCE

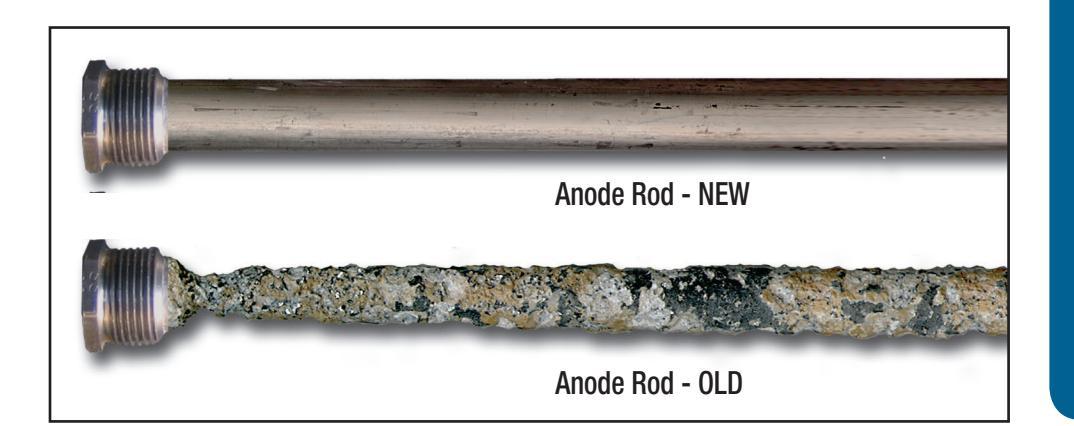
Look at the top of your water heater to locate the anode rod. In most cases the hex head is exposed and in some cases it is hidden under the sheet metal cover. If exposed a 1 1/16" 6 point socket with long breaker bar will be required to remove it. If hidden an easy solution would be to remove the nipple on the hot water side with a pipe wrench and install a nipple outlet anode rod.

Most gas or electric water heaters require a standard rod length of 44".

On some tall electric or solar storage tanks a rod 51" in length would be required. If the ceiling height over a heater is a problem in installing the anode rod, an anode rod which has sausage links can be bent into place or a hole cut above the heater to the attic can accommodate installations. Magnesium rods are supplied as standard.

As long as the magnesium anode remains in the tank, in an active state, there will be no corrosion of the exposed steel.

The anode should be replaced when there is 6" or more exposed core wire at either end. *Rheem Manufacturing Company, Waier Heater Division, June. 1988.*

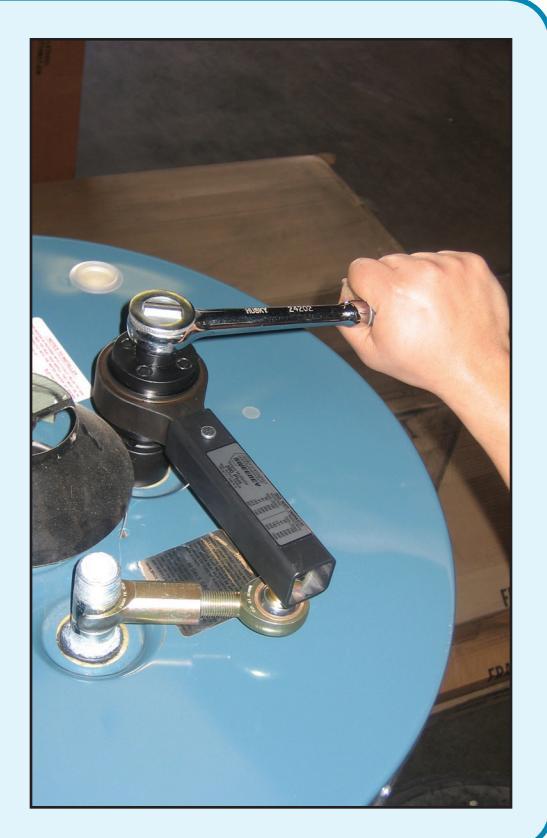
Rod Remover with Socket UT-362

ROD REMOVER-FOR REPLACEMENT OF ANODE RODS

When tanks are manufactured, anode rods are installed with an impactor. With age threads become frozen and are difficult to remove with conventional breaker bars, ratchets and sockets.

The cure is a rod remover, a tool modified for the sole purpose of easy removal and replacement of anode rods by applying a maximum 227 lbs at the top with a conventional 1/2" drive 12" ratchet. A gear ratio increases that to 750 lbs at the head of the anode rod.

ROD REMOVER PLUS 1-1/16" DRIVE 6 POINT SOCKET

- Multiplies your strength 3 1/3 times to easily remove even the most stubborn of anode rods.
- Built-in leverage bar stops tank from turning, even when empty.
- Works in close proximity to connector piping and venting to speed anode replacement time.
- Built with industrial quality components for years of trouble free service.
- Defects in material or workmanship, 1 year limited warranty.

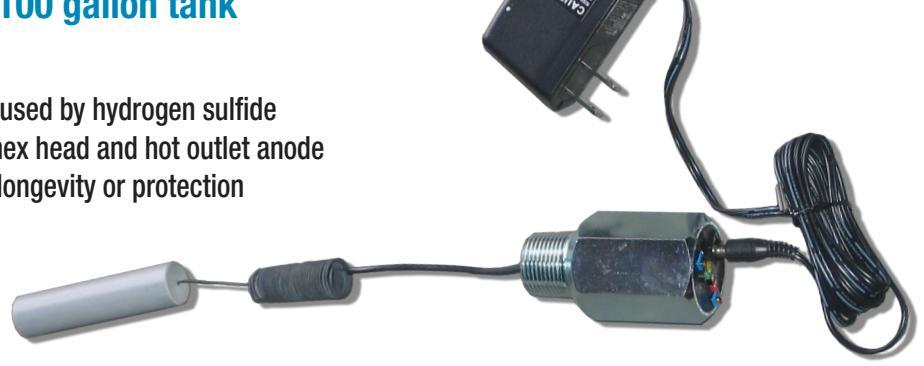
POWERED ANODE

Powered Anode Rod with transformer and 6' lead, Model# AR148 - Services 20-100 gallon tank

- Eliminates rotten egg smell in water caused by hydrogen sulfide
- Replaces water heater tank's existing hex head and hot outlet anode
- Water softener use does not affect the longevity or protection
- Extends life of water heater tank
- 7 Year Warranty
- Made in the USA

Note: MFGS Bradford White, some state and A/O Smith have the the anode attached to the hot outlet nipple. To adapt the **Model AR-148** power anode, a 3/4" brass tee and 3/4" plastic lined nipple of sufficient length to extend past the thickness of insulation will be required. Most gas heaters will require a 3" long nipple and on electric water heaters MFG after april of 2015 a 6" long nipple is required.

Model AR-148 powered anode when installed to replace the exsisting hex head anode may require a longer nipple and brass coupler to clear the insullation to complete the install.

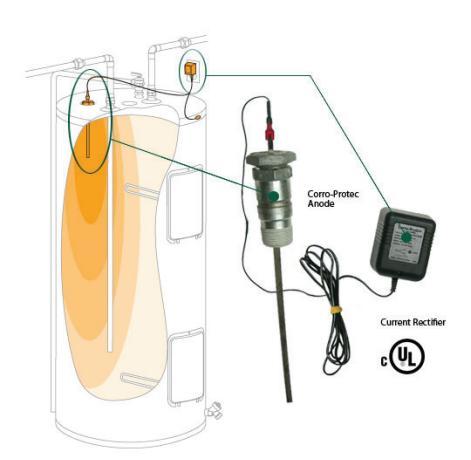
Model AR-149 and **Model AR-150** powered anode is adaptable to replacing the hex head anode only. Designed with a 3" long nipple. It is universal to most gas and electric water heaters.

Powered Anode Rod with transformer and 6' lead, Model# AR149 - Services 40-60 gallon tank Model# AR150 - Services 10-30 gallon tank Made by Corro-Protec

- Flimintone watten and amall in water several by budy
- Elimintaes rotten egg smell in water caused by hydrogen sulfide.
 Replaces water heater tank's existing hex head anode only.
- Water softener use does not affect the longevity or protection
- Water solutioner use does not anect the longev
 Extends life of water heater tank
- 20 Year Manufacturer's Warrantv
- 20 Year Manufacturer's warra
 Mode in Oenede
- Made in Canada

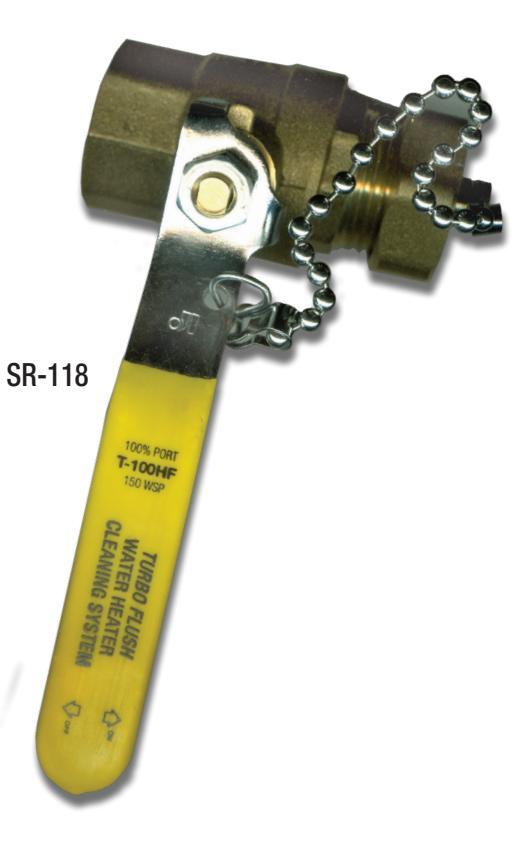
WATER HEATER FLUSH VALVE includes cap & chain assembly Turbo Flush Water Heater Cleaning System Imprinted On Handle

Replace the conventional straight cold water inlet with a tube which is longer and has a curve at the end, (see page 7) and replace the tank's original (usually plastic) drain valve with an easily operated brass ball valve (see page 7). As water enters the tank through the new tube, its swirling motion lifts scale off the bottom and flushes it out the large opening of

the brass ball valve. (Some heater manufacturers void their warranties if scale build-up is the cause of tank failure. Others facilitate flushing by adding various expensive devices to reduce sediment build-up).

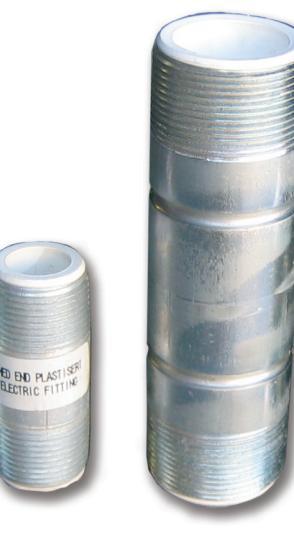
PLASTIC LINED DIELECTRIC NIPPLES

3/4" X 1 [·]	13	/1	6'	,				WCP-100
3/4" X 3"								WCP-102
3/4" X 4"								WCP-103
3/4" X 6"								WCP-104
1" X 3"								WCP-105
1"X 6"								WCP-106
Larger Diameter Nipples								
available upon request

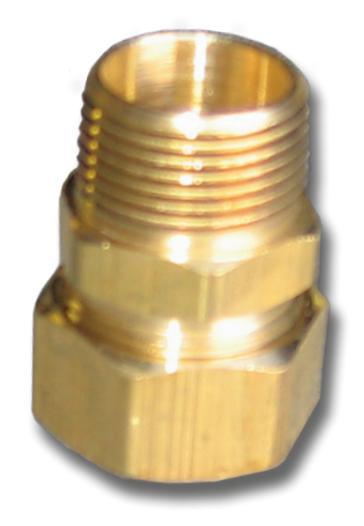
UNIONS

7/8" COPPER COMPRES	SION X 3/4"
FIP BRASS	WCP-107
MIP BRASS	WCP-108

With time, that area corrodes and clogs restricting flow; just like a galvanized nipple. For best results, use a 3/4 FIP or MIP brass x 3/4" compression union. (see page 9)

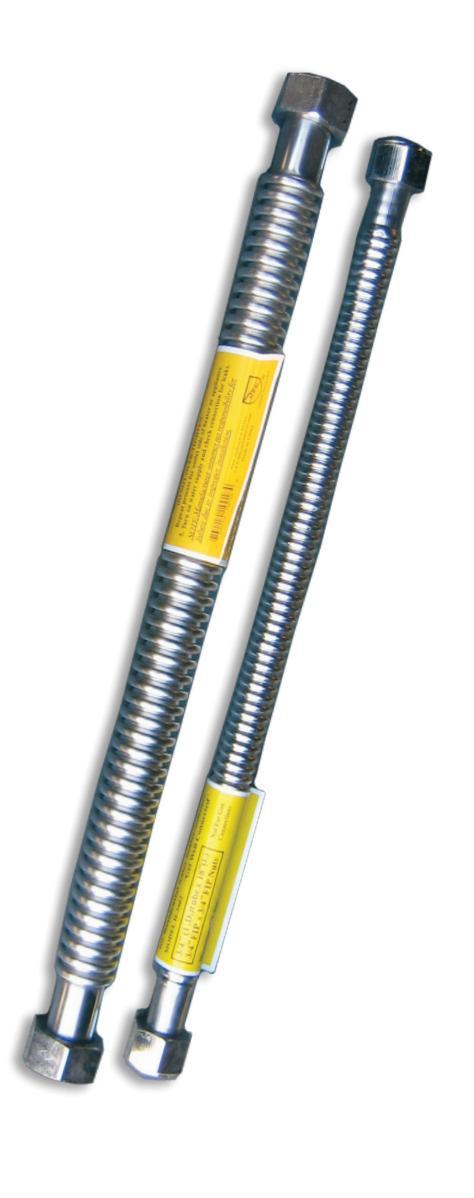
STAINLESS ULTRA FLEX LINES

12" X 3/4" FIP X FIP	WCP-109
18" X 3/4" FIP X FIP	WCP-110
24" X 3/4",FIP X FIP	WCP-111
18" X 1" FIP X FIP	WCP-112
24" X 1" FIP X FIP	WCP-113
